# TEST REPORT

**SLIP RESISTANCE CLASSIFICATION OF  
NEW PEDESTRIAN SURFACE MATERIALS  
AS/NZS.4586:2004**

**Neoflex (with Fresh Finish)**

**22/05/2015**

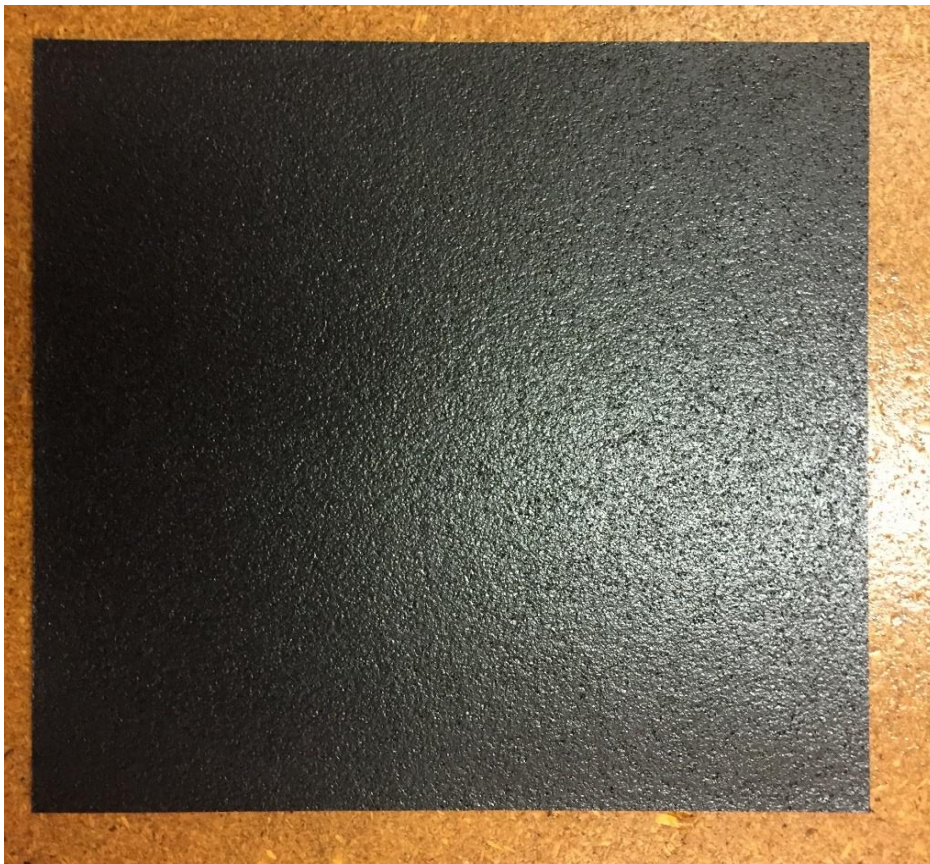
## TEST PRODUCT IMAGE

**Product Description:** Neoflex (with Fresh Finish)
